NINE MILE RUN STREAM RESTORATION

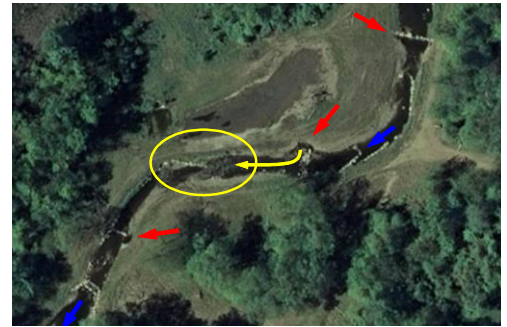
Failures as seen in Google Earth

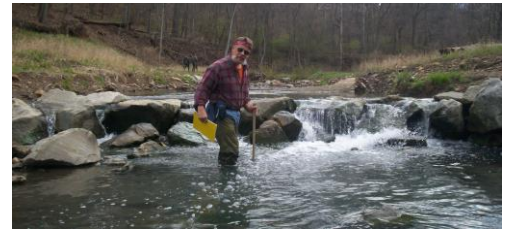
Dave Derrick at Cross Vane Fish Barrier

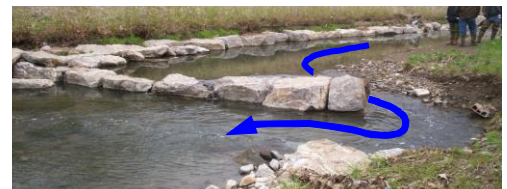
Typical Flanked Structure

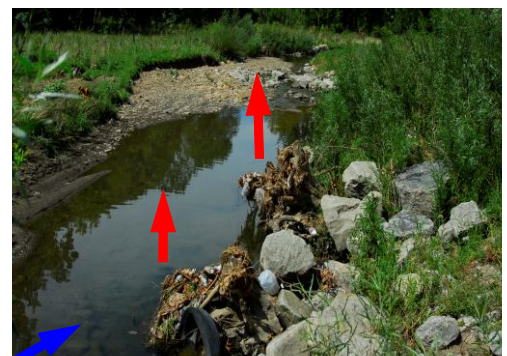
Root Wads Causing Bank Failure
