## Hockley Hills Trout Stream Relocation and Natural Channel Design

Road widening in rural areas often involves impacts to streams. A government stimulus project in a rural township in southern Ontario sought to widen an existing road and replace a failing bridge. A high quality stream was located parallel to the road but had poorly developed habitat and channel characteristics due to road maintenance impacts. As part of compensation requirements, the stream was moved away from the road and into a nearby field, located on private property. This provided sufficient room for a “natural” channel design that would align stream flows to the new bridge and provide in-stream habitat to support a native Brook Trout population.

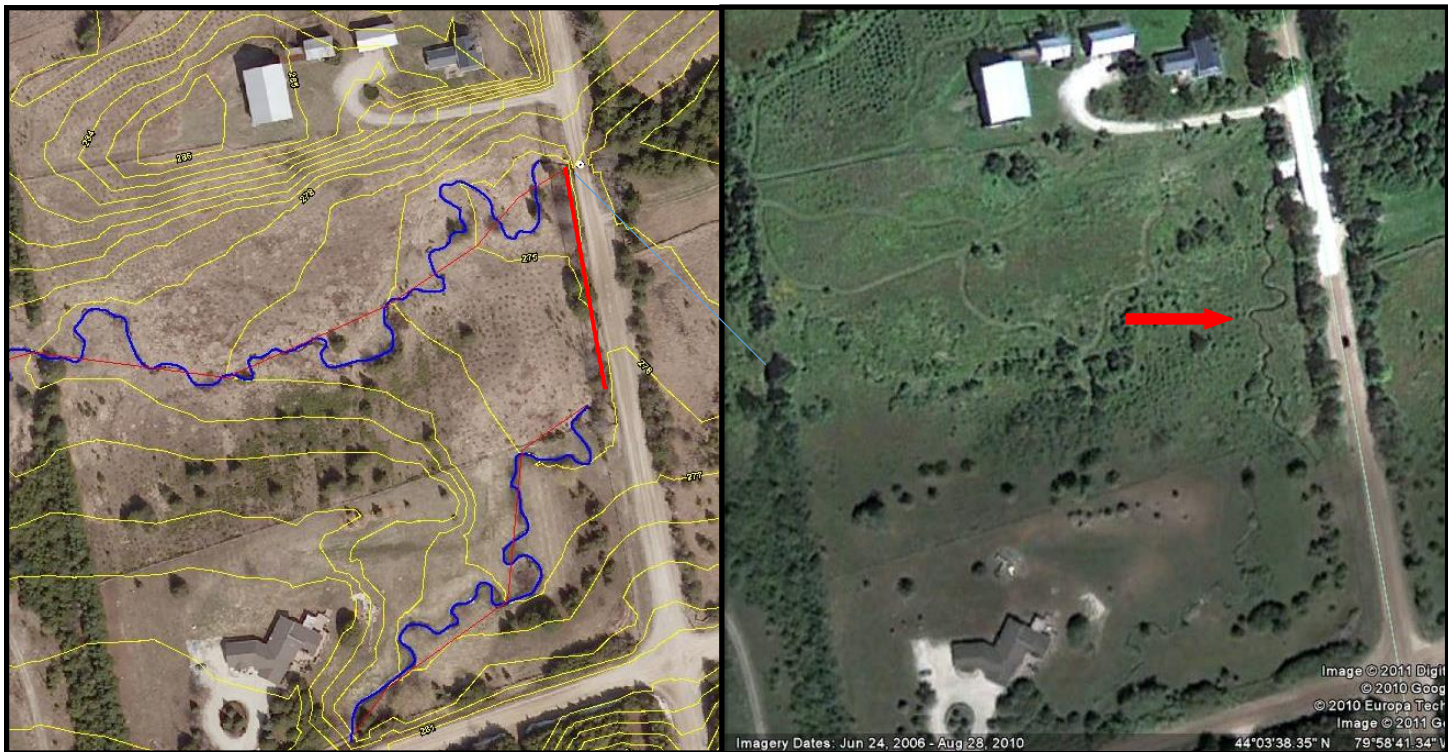
**Left photo shows pre-construction condition and existing streams with channel along road (red line);  
Right photo shows meandering natural stream channel as completed.**

The natural channel design was based on geomorphic characteristics and stream channel dimensions produced from on-site assessments and GIS based analyses. The stream was designed to duplicate existing unaltered headwater streams located nearby (left photo). The design channel included various habitat structures including Engineered Rock Riffles, Log Revetment Angle-Slams, and undercut banks based on modified design structures originally developed by Dave Derrick. The “new” channel created more in-stream habitat than the one it replaced due to the greater amount of meandering, increasing channel length, and in-stream structures. The design channel was constructed in one-week and can be seen below (right photo). Riparian restoration was also completed using native vegetation. The design plan, structure drawings, and additional photos of completed habitat structures are also shown on the next page.

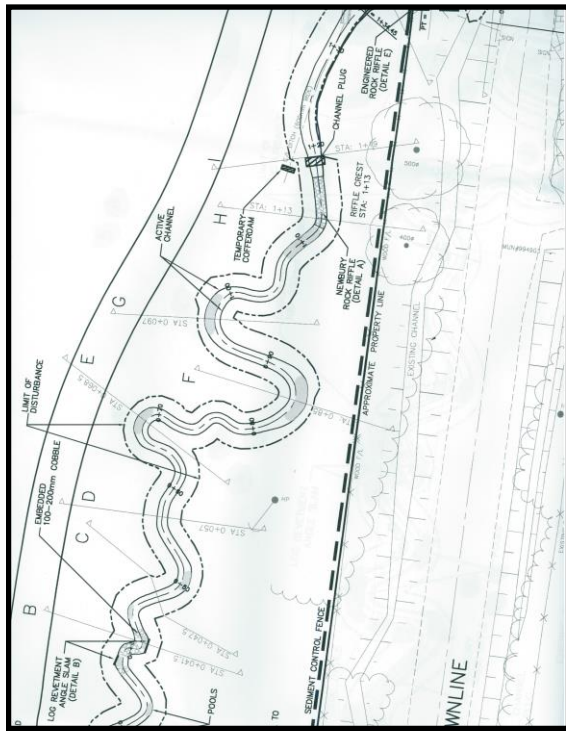
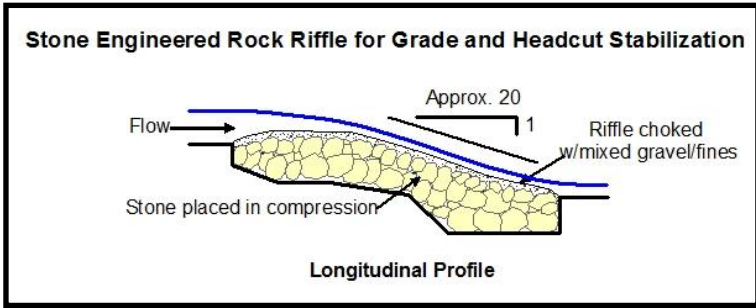
Drawings of the channel design (left) and habitat structures (right).

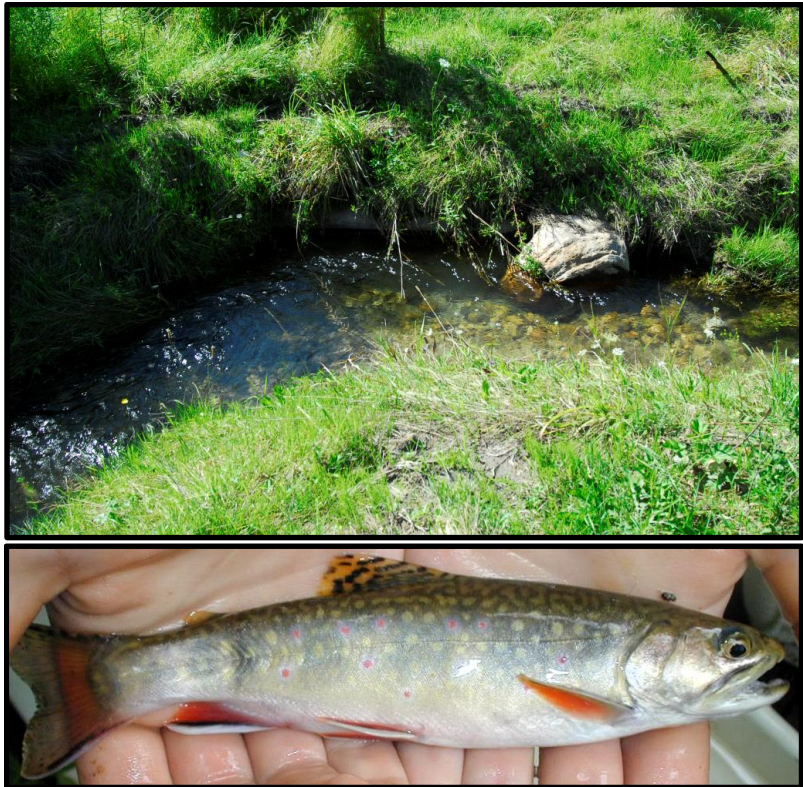
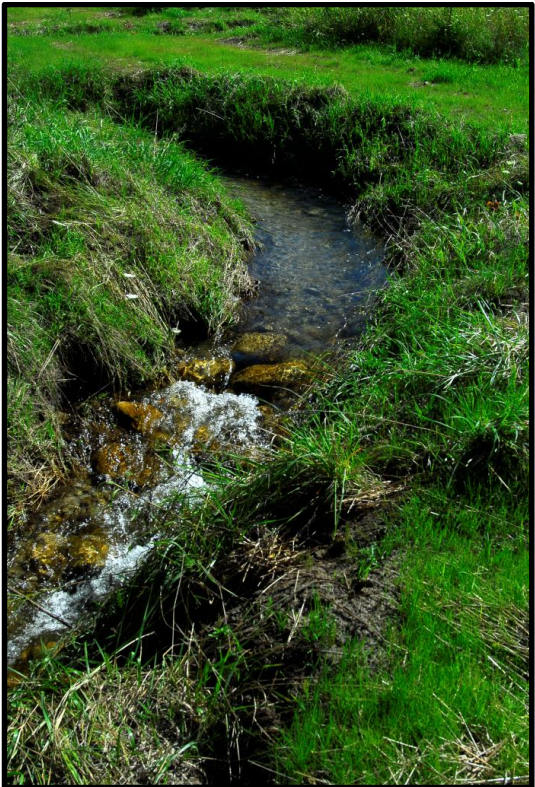
As built Log Revetment Angle-Slam (upper left photo) and Engineered Rock Riffle (right photo); Resident Brook Trout (lower left photo).  
 For additional information contact Dr. Bruce Dicks on at 814-806-6073 or [bdickson@redhorsenvironmental.com](mailto:bdickson@redhorsenvironmental.com)
