## Trout Run Streambank Stabilization Project, Erie County, PA

RedHorse Environmental designed, permitted, and constructed a longitudinal-peaked-stone-toe-protection (LPSTP) bioengineering structure on Trout Run in Fairview Township, Erie County. The structure addressed a stream bank failure occurring on Trout Run adjacent to the Fairview Area Historical Society on Avonia Road in Fairview.

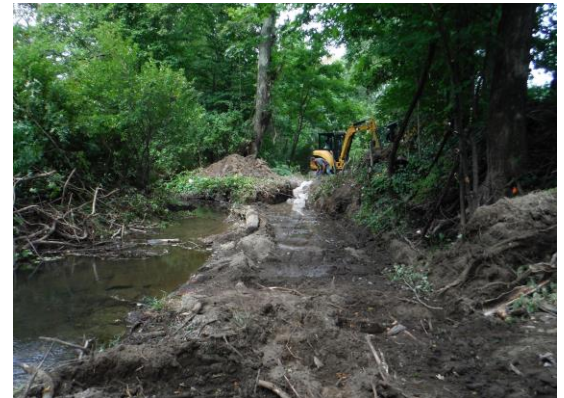
**Trout Run prior to LPSTP installation  
(bank failure to right of stream channel)**

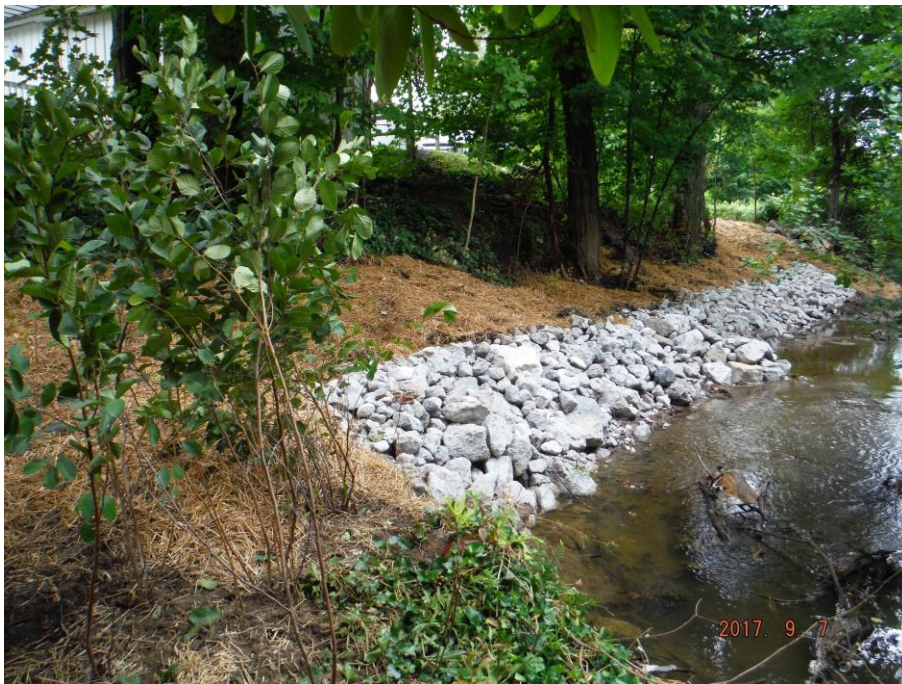
**Constructed LPSTP  
looking upstream**

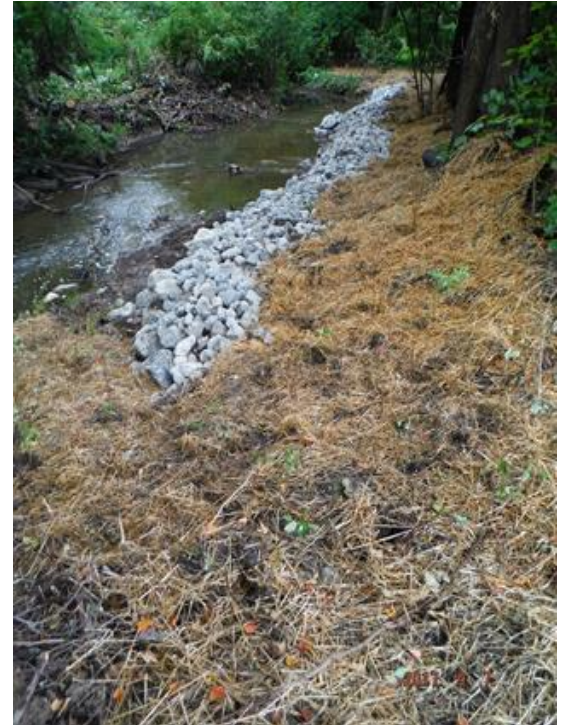
**Constructed LPSTP**
